Cloned from Removal File  
I- Action memo

## II. SITE CONDITIONS AND BACKGROUND

**ASSESSMENT OF SCIO POTTERY  
SCIO, OHIO**

VISUAL SITE INSPECTION REPORT

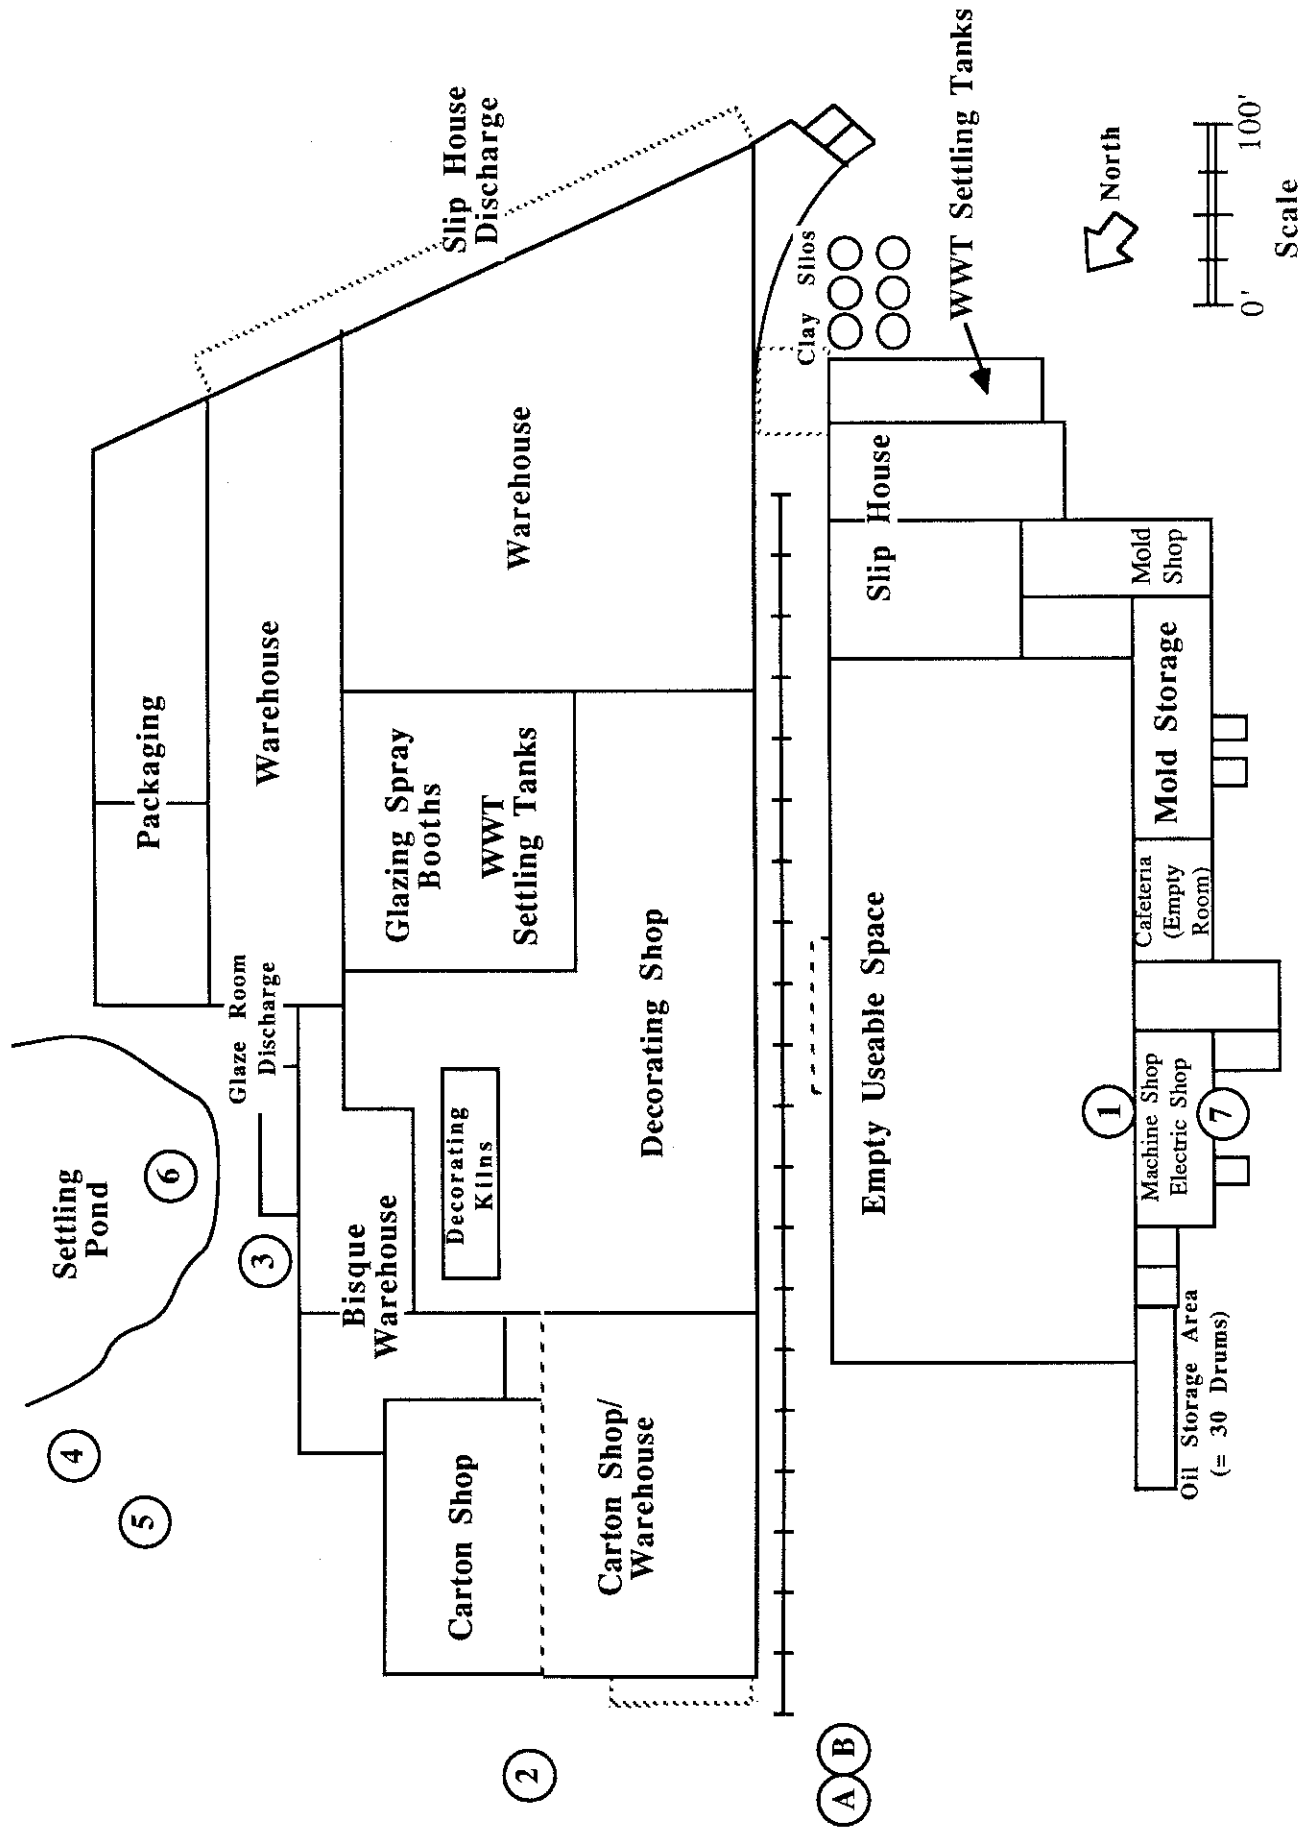
**Figure 2 SCIO Pottery Company  
Facility Layout and SWMY Locations**

(Circled Numerals Designate  
SWMU Locations)

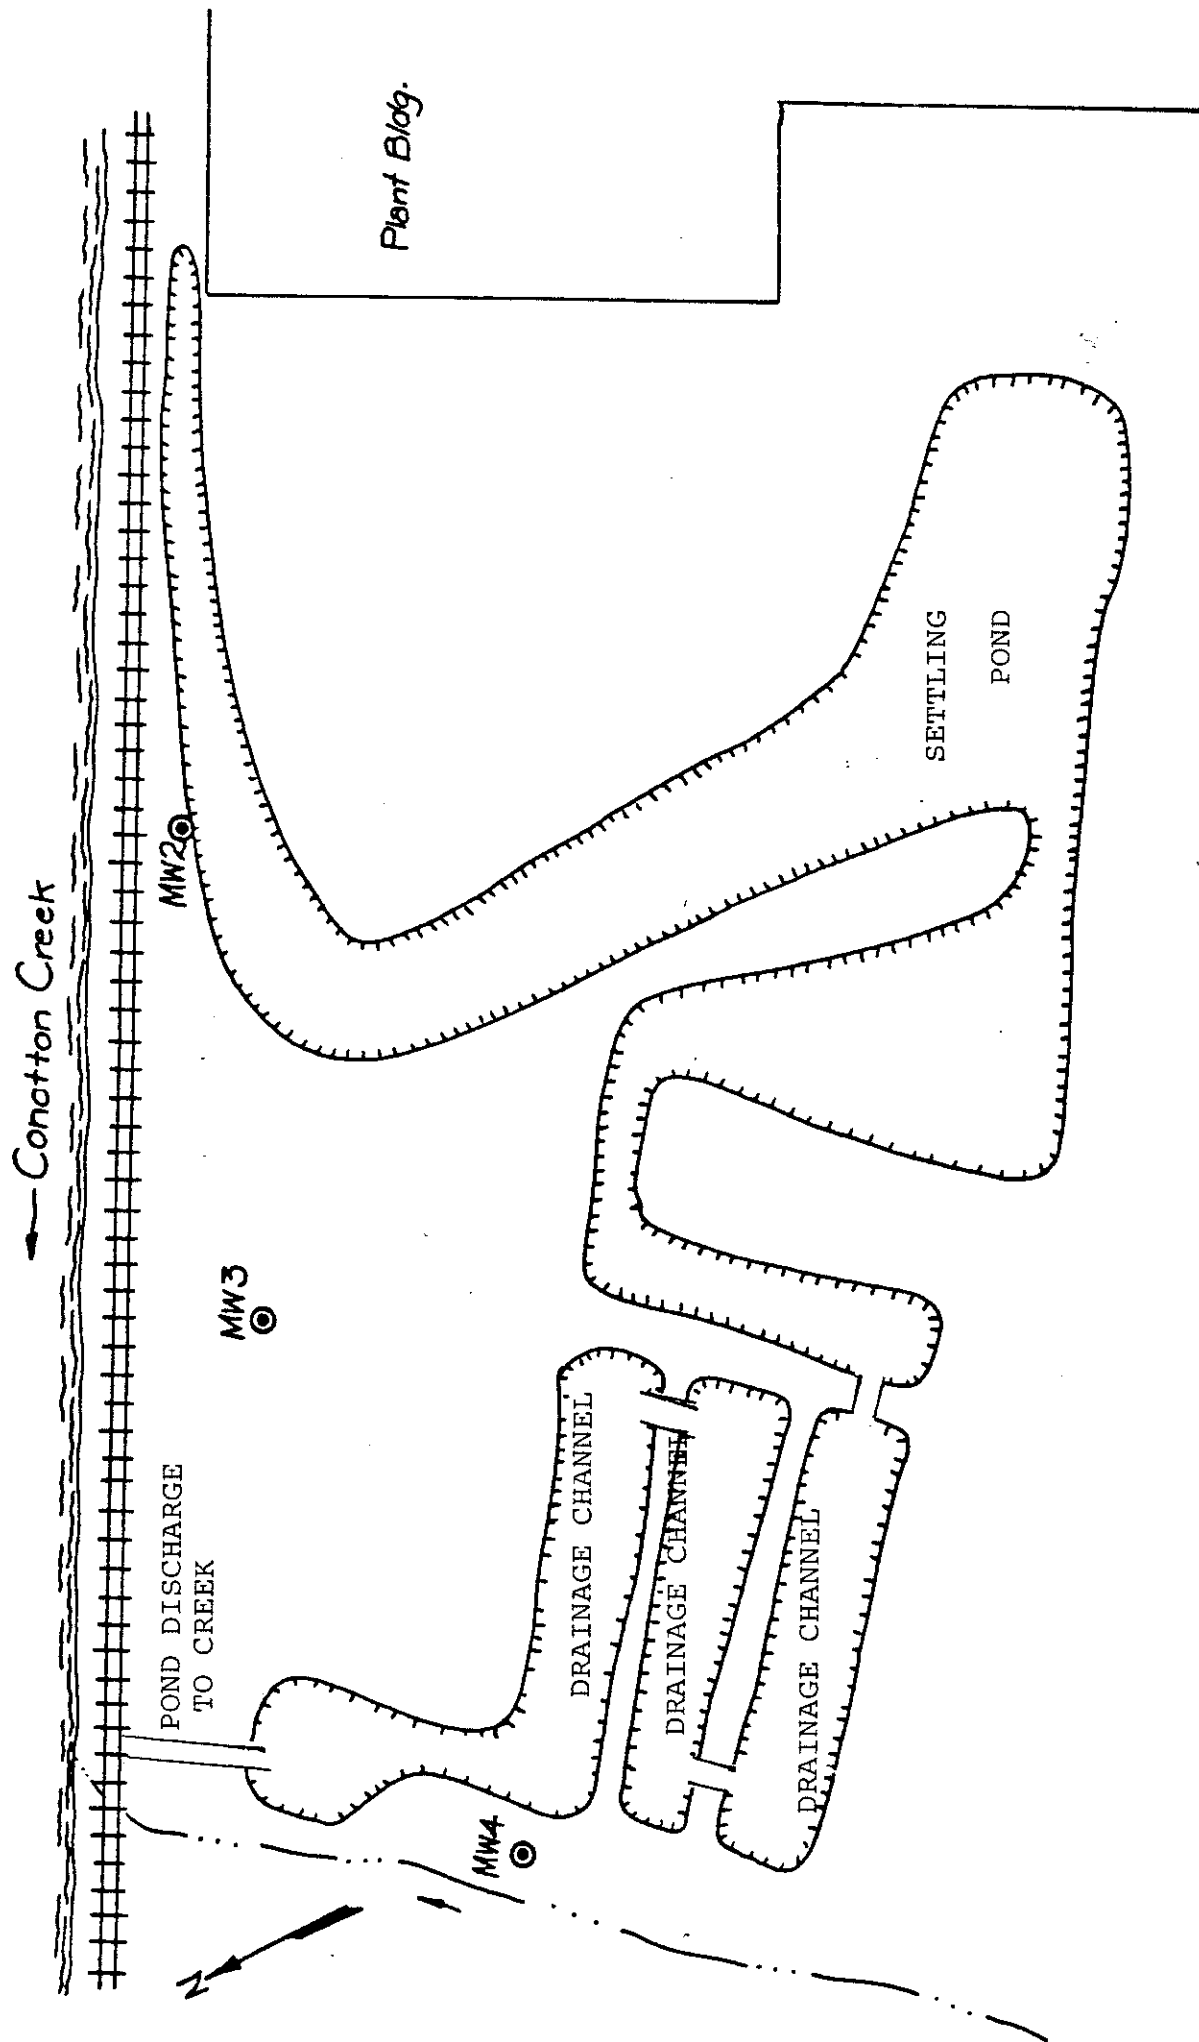
Figure 4. Scio Pottery Settling Pond

● Water Well

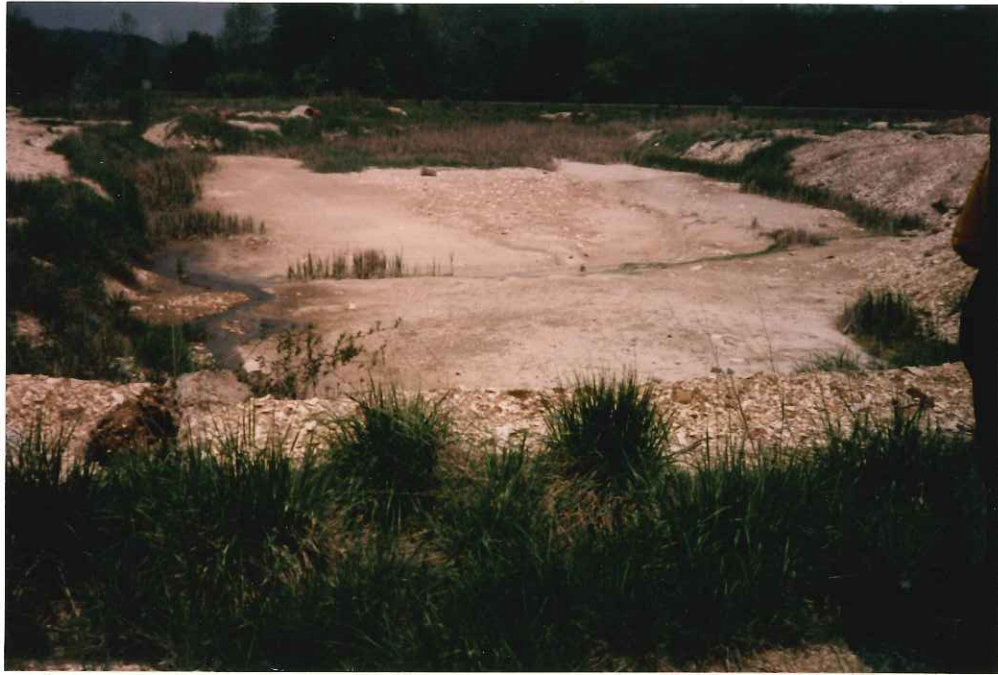
Photo 1: SWMU no. 1 -- Settling Pond; direction of photo is east.  
Note embankment covered with broken pottery.

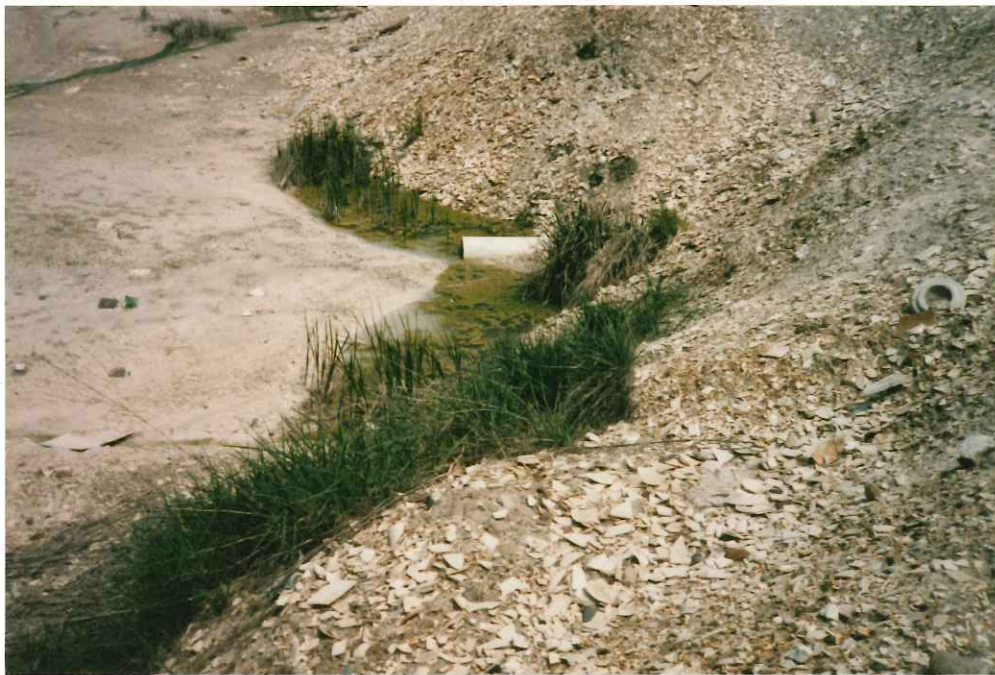
Photo 2: SWMU No. 1 -- Settling Pond; direction of photo is east.  
Note discharge pipe in photo center.

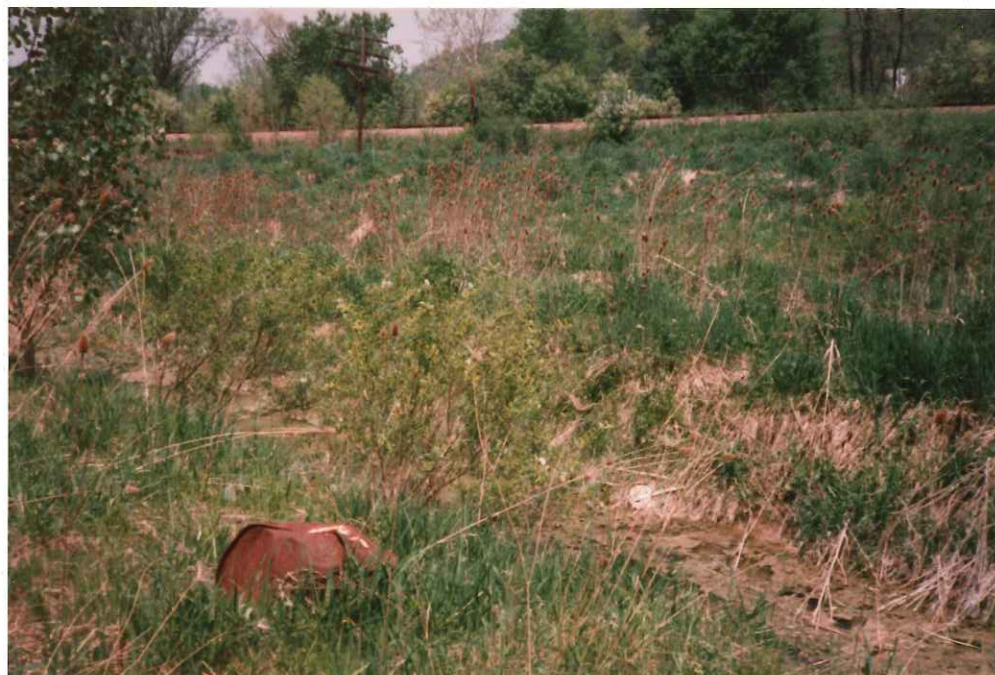
Photo 4: SWMU No. 1 -- Settling Pond Drainage Channel; direction of photo is east. Note rusted drum in foreground and stagnant water in channel. Also note railroad tracks in background.

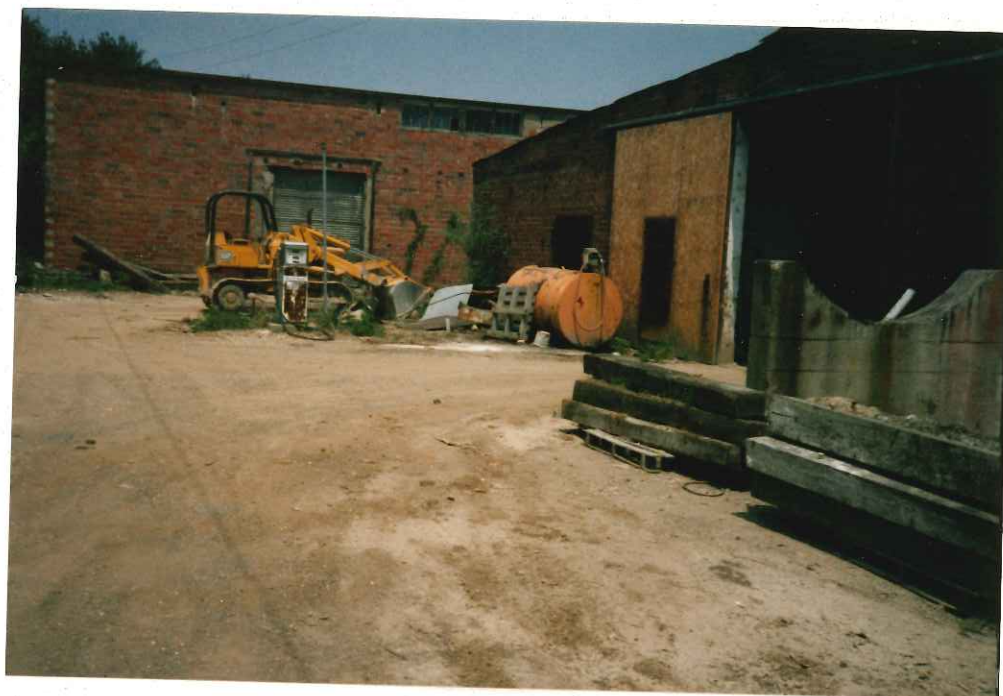
Photo 7: Other Area of Concern -- Underground Storage Tank; direction of photo is south. The unit is in the area of the gasoline pump.

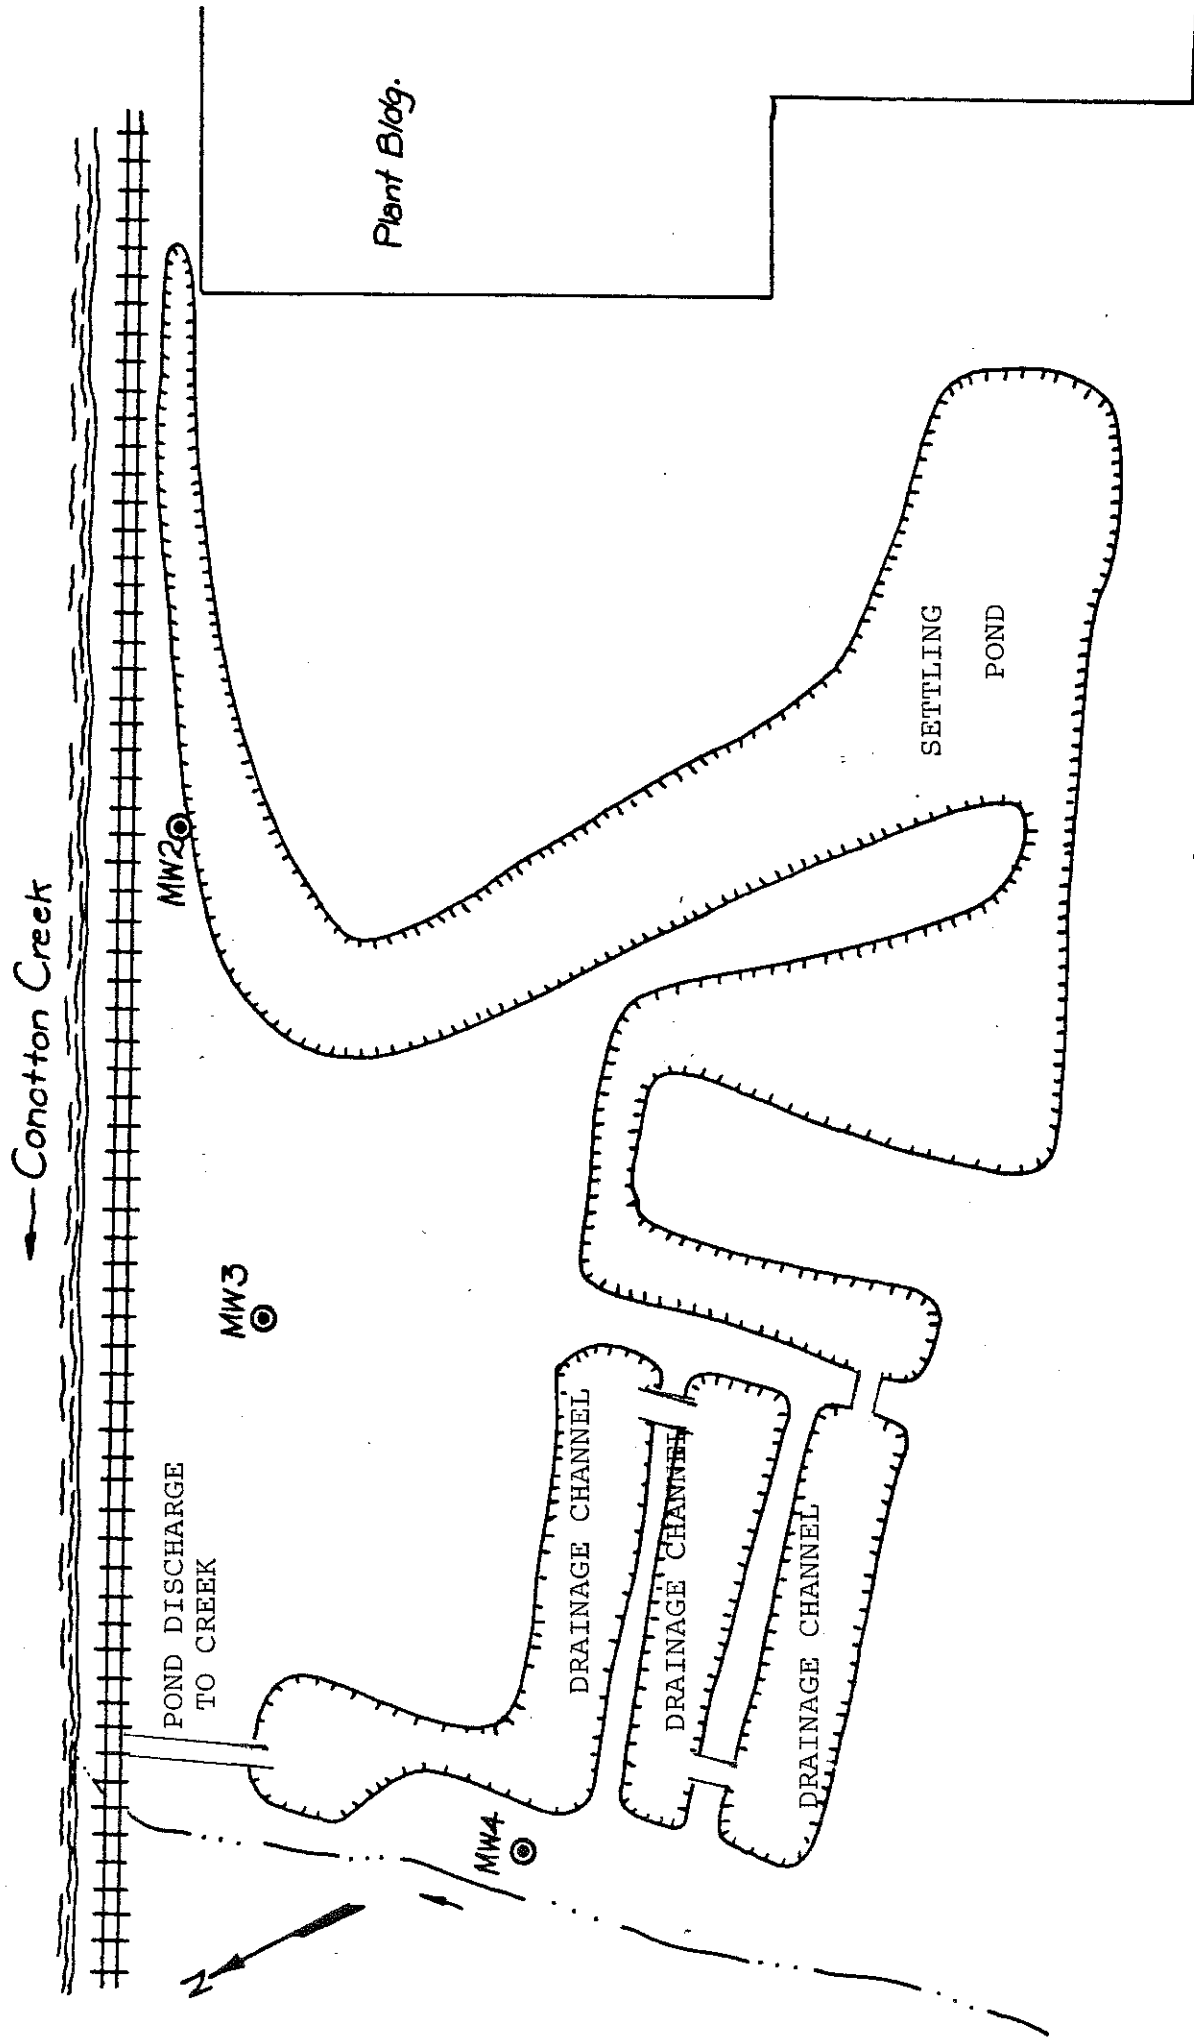
Figure 4. Scio Pottery Settling Pond

Water Well

**Release Controls:** No release controls were noted. The unit is unlined. Four monitoring wells have recently been installed in the vicinity of this unit (see Figure 4) (Reference 7).
